## The History of the Cleveland Pools – the Central Cottage

### Central Cottage – its structure

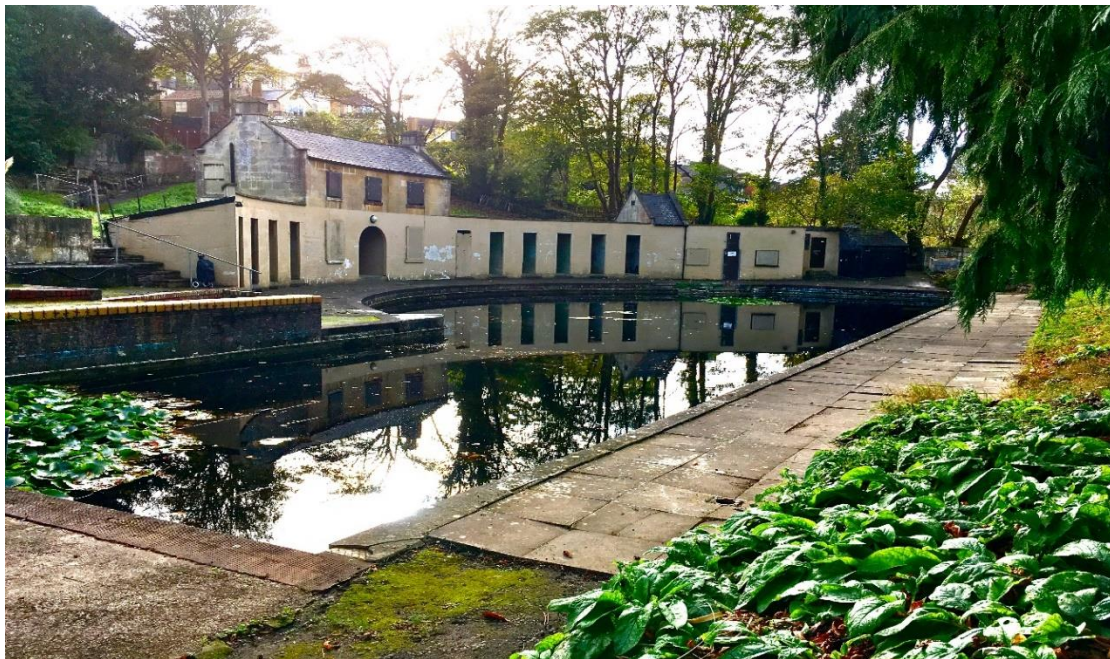
The cottage within the crescent of changing rooms, pre – restoration 2018  
*Photograph courtesy of Sally Helvey*

The whole structure of the crescent of changing rooms with its central cottage is original, dating from 1815 - 1816; a two-storey cottage is flanked on either side by wings of six changing cubicles. There is a taller block and extension to the west, integral to the original build, which housed the Ladies Pool, Perpetual Shower and two large dressing rooms. It is likely that the whole crescent was designed by John Pinch the Elder, a skilled architect who designed many notable buildings in the wider Bathwick area. Amongst the original fee-paying subscribers to the Pools, Pinch is one of the few whose fee is shown as 'gratis', acknowledging their contribution to the inception of this remarkable Georgian bathing facility.

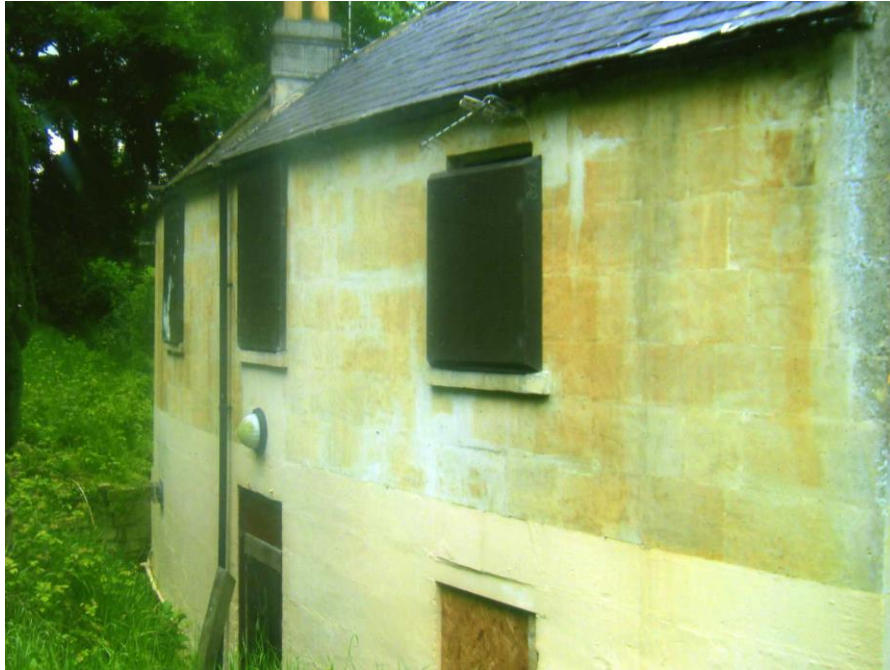
The south elevation of the cottage has a central door accessed by steps which may be original, a window to its east and three above.

South Elevation of Cottage – Pre-Restoration  
*Photograph courtesy of Ainslie Ensom MSc.HistBdgCons*

One room deep, front and rear walls curved with the crescent, the cottage has chimney stacks at either gabled end with a 'blind' window in each end wall. Blind windows indicate that original windows were blocked to avoid the window tax that was not abolished until 1851. The slate roof, with remnants of lime torching, is original. The north elevation has a central arched opening with a window opening to either side, and three above. The existing windows are from the second half of the 20<sup>th</sup> century. The central archway, through to a lobby on the south side, gave access from the entrance pathway to the main pool. This was the only access to the lower pool, probably until the early 20<sup>th</sup> century when steps were created to facilitate access from the pathway, around the crescent of changing rooms.

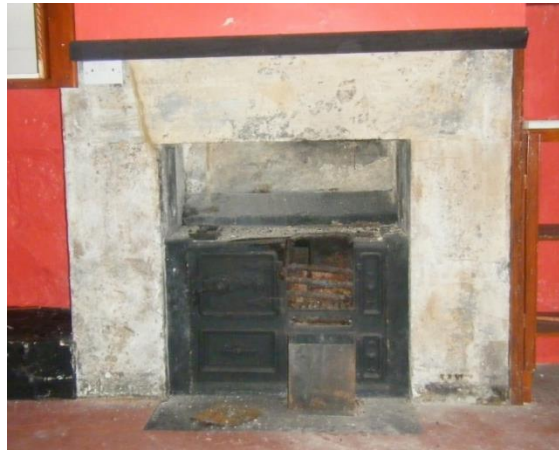
Cast iron range in west ground floor room of cottage pre - restoration  
*Photograph courtesy of Ainslie Ensom MSc.HistBdgCons*

- The ground floor room to the west has a plain stone fire surround containing a small cast iron range].
- The upper floor room to the west has a cast iron hob grate with a stone surround.
- The upper floor room to the east has a plain stone surround although it has lost its grate, a simple plaster cornice, timber skirting boards, floorboards, door, and architraves.
- The boarded ceiling above the north lobby.

There are four fireplaces inside, with three remaining cast-iron ranges. The ranges provided heating, washing, and cooking and the Cleveland Pools Trust wished to make a feature of them to explain to visitors (especially children) what living conditions were like in the nineteenth and twentieth centuries. One of the ranges is dated 1842 and was produced by the Coalbrookdale company. Another range is likely to be one of the few ranges manufactured by 'Gardiner & Sons Ltd', now Gardiner Haskins of Bristol. A further range is a Falkirk type range, possibly dating from the 1900 – 1920 period, very common in working buildings and poorer households.

Surviving areas of lime plaster, and lath and plaster, are retained and traditionally repaired in three coat haired lime plaster throughout the first floor residential flat in the cottage building. The first-floor boarding was lifted to allow upgrading for thermal, acoustic and fire separation before being reinstated. The cast iron ranges are repaired and refurbished, although not as working fireplaces.

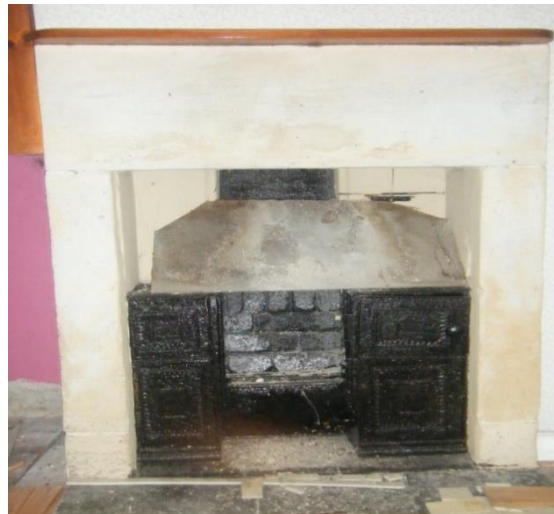
Cast iron hob grate in upper west room in cottage –pre restoration.  
*Photograph courtesy of Ainslie Ensom MSc.HistBdgCons*

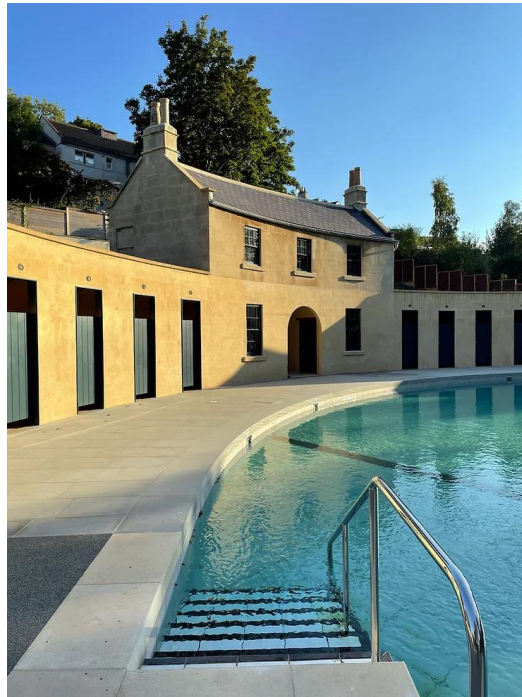
*View of the restored cottage in 2022, courtesy of the Cleveland Pools Trust*

During restoration of the historic 'crescent' of buildings, cleaning was followed by trial limewash samples to achieve a good match to the stone colour – historically, the lower storey of the building had been limewashed, then whitewashed (along with some masonry paint) – the continued use of limewash provides an appropriate solution to unify the elevation, tolerate flood conditions and provide a highly-breathable, antibacterial and antifungal finish to masonry surfaces.

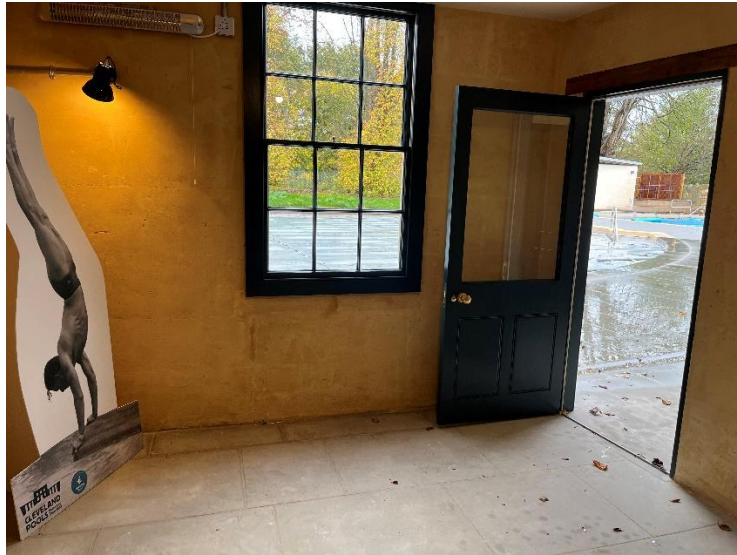
*Cottage Interior View Post – Restoration,  
courtesy of the Cleveland Pools Trust*
